Project: Albuquerque Federal Building

**CONC. TEST RESULTS - PETROGRAPHIC EXAMINATION
REPORT BY CONSTRUCTION TECHNOLOGY LABS**

Re: Petrographic Examination of Concrete Cores, Albuquerque Federal Building,
Albuquerque, New Mexico

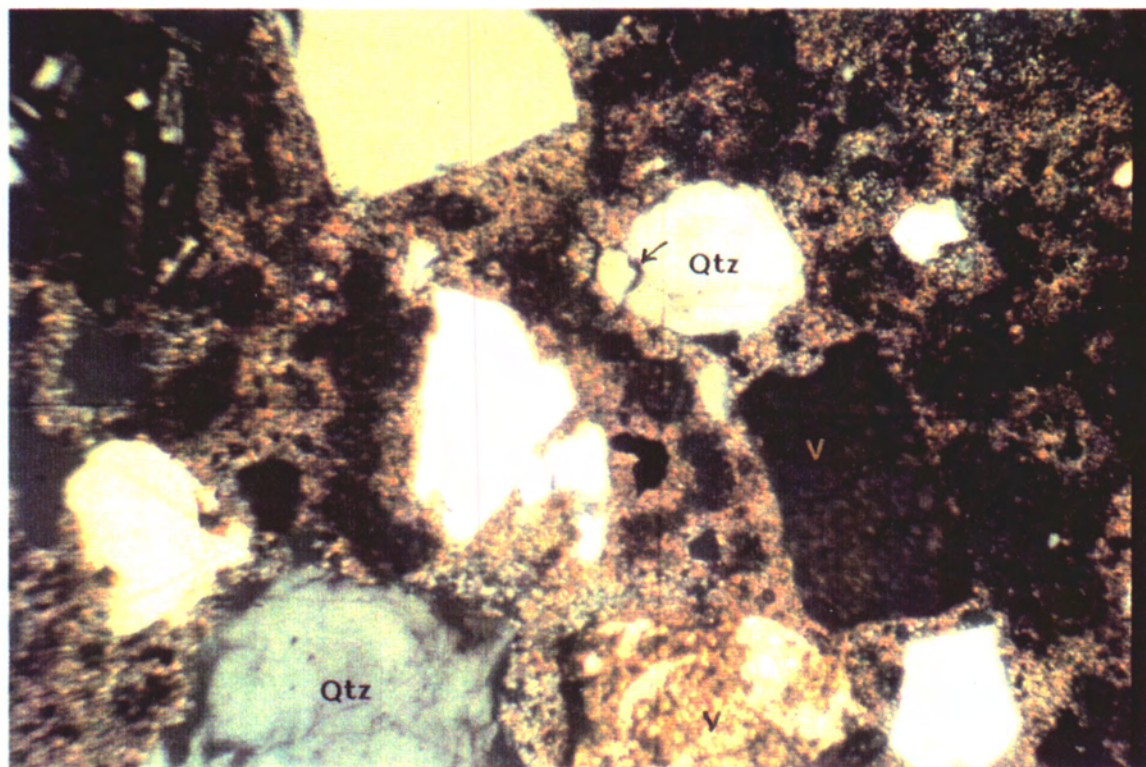
Photo #11. Core-6th floor Carbonation of the matrix appears as wide rims around the aggregates. 40X, XP, 1/2" depth

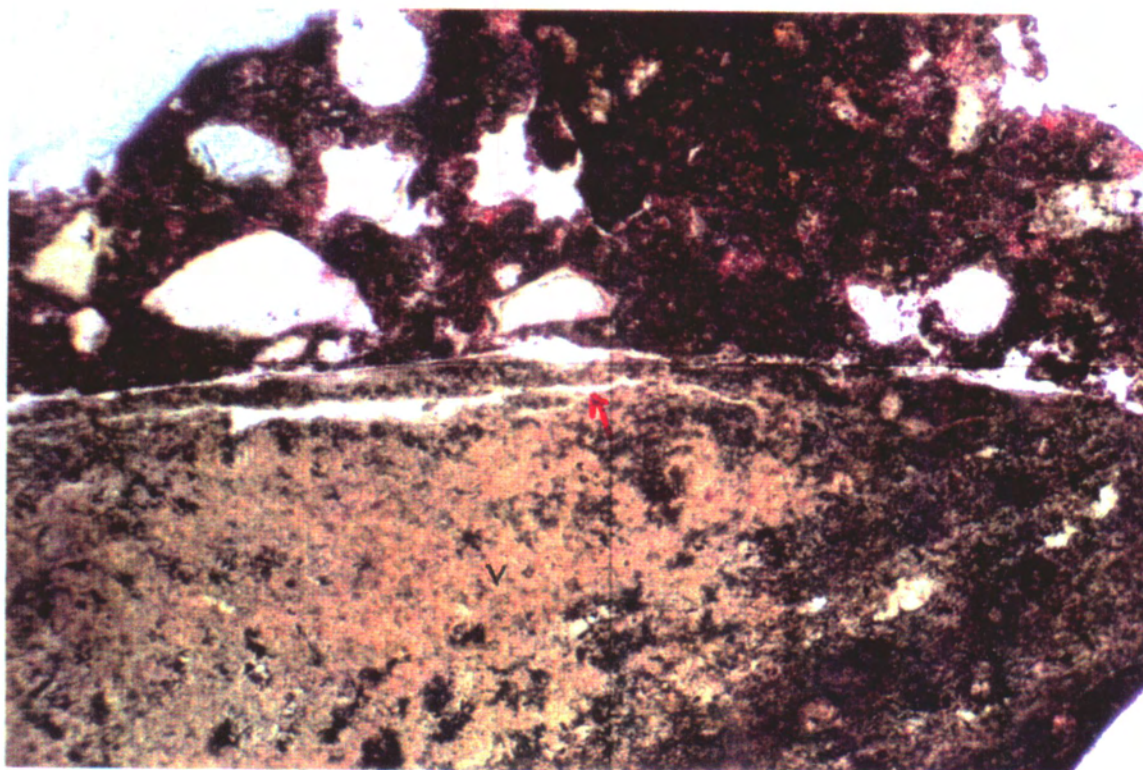
Photo #12. Core-6th floor Extensive cracking between a volcanic fragment (bottom) and matrix (top). the matrix is dyed red by carbonate indicator dye. 40X, PL, 1 1/4" depth

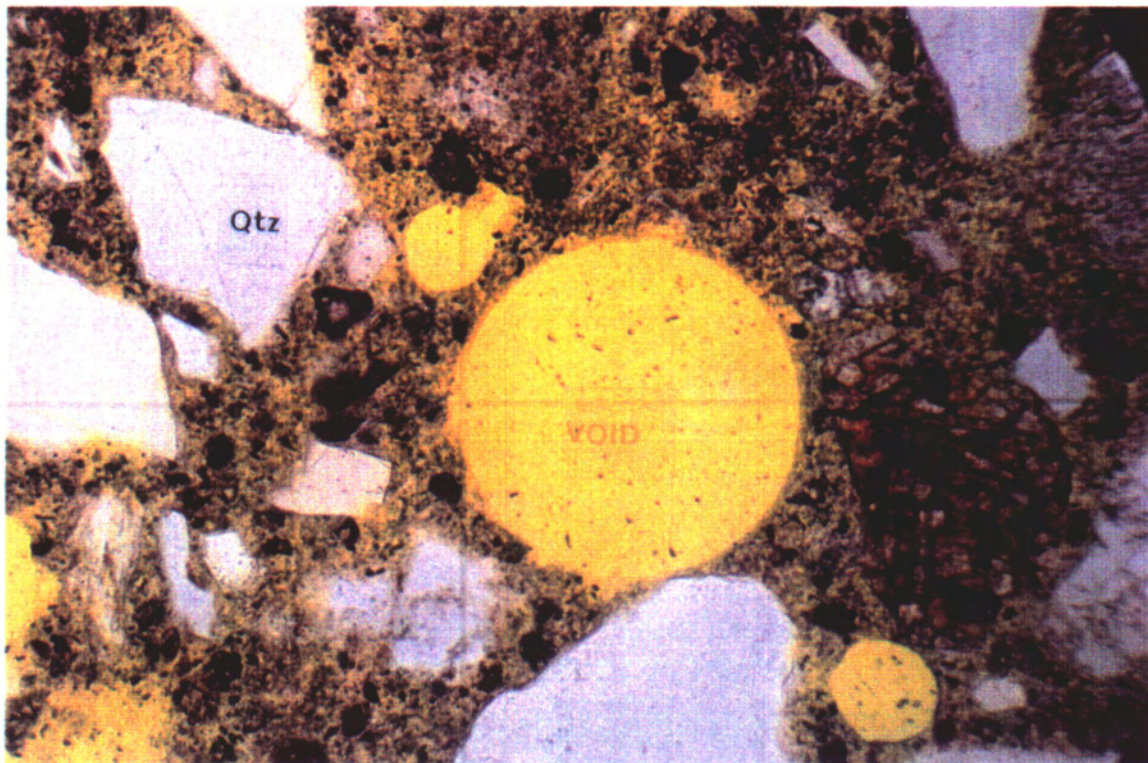
Photo #13. Core-6th floor Highly carbonated matrix. Air voids are highlighted by yellow fluorescent epoxy. 40X, PL, 1 5/8" depth

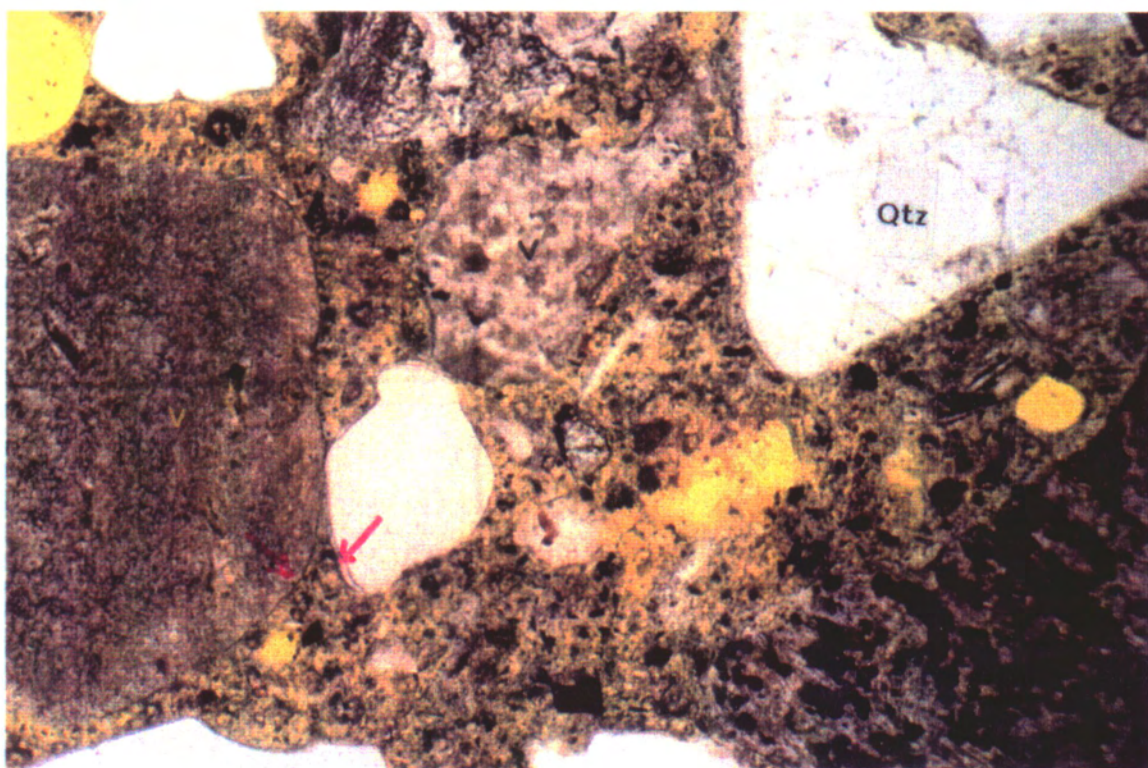
Photo #14. Core-6th floor Microcracks around aggregate (arrows). Highly carbonated matrix. 40X, PL, 2" depth
